Region 9 Enforcement Division
75 Hawthorne Street
San Francisco, CA 94105

Inspection Date(s):	9/29/2015		
Time:	Entry: 10:00 am	Exit: 12:00pm	
Media:	Water		
Regulatory Program(s)	Clean Water Act NPDES /CAFO Dairy		
Company Name:	Legend Dairy Farms #2		
Facility or Site Name:			
Facility/Site Physical Location:	<div style="border: 1px dashed black; padding: 2px;">Ex. 6 Personal Privacy (PP)</div>		
Geographic Coordinates:			
Mailing address:	P.O. Box 2500, Chino, CA, 91708		
Facility/Site Contact:	Ron Peitersma	Title: Operator	
	Phone: <div style="border: 1px dashed black; padding: 2px;">Ex. 6 Personal Privacy (PP)</div>	Email:	
Facility/Site Identifier:	NPDES CAG018001 / Order R8-2013-0001, General waste discharge requirements for CAFOs (dairies and related facilities)		
NAICS:	112120 Dairy Cattle and Milk Production		
SIC:	0241 Dairy Farms		
Facility/Site Personnel Participating in Inspection:			
	Name	Affiliation	Title
	Ron Peitersma	Legend Dairy	Operator
EPA Inspector(s):

The facility has applied for coverage under NPDES CAG018001 / Order R8-2013-0001, General waste discharge requirements for CAFOs (dairies and related facilities) within the Santa Ana Region.

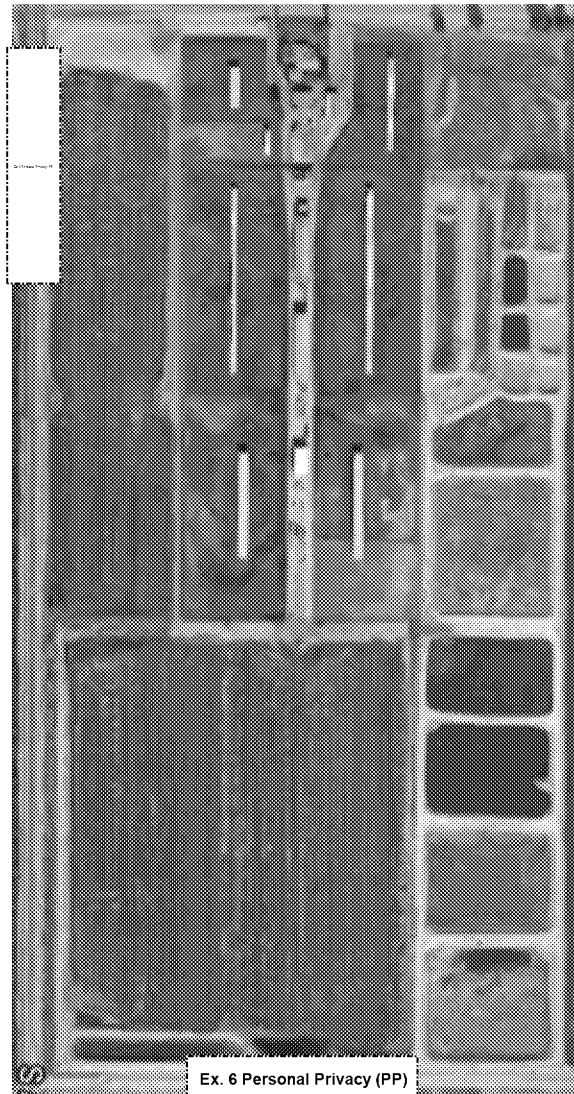
The facility has 16 ponds located on the eastern side of the dairy. (see photo 1) Washwater from the milk barn areas gravity flows to the northern ponds (photo 6), and washwater either gravity flows or is pumped to the ponds in series towards the spillway located at the southern end of the facility.

Photo 1: facility overview

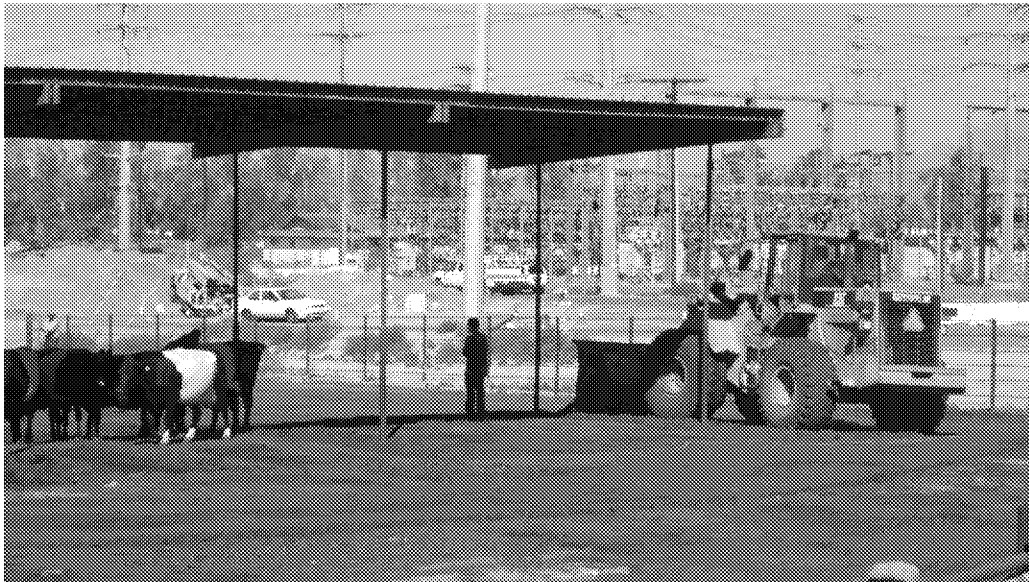
No issues noted. Corrals were being scraped and stockpiles of manure were being removed at time of inspection (see photo 1-2. Operator stated corrals would be continuously scrapped until the rainy season to remove manure. Manure did not appear to have been present for more than 180 days.

Photo 2: Corrals being scraped and manure being hauled off

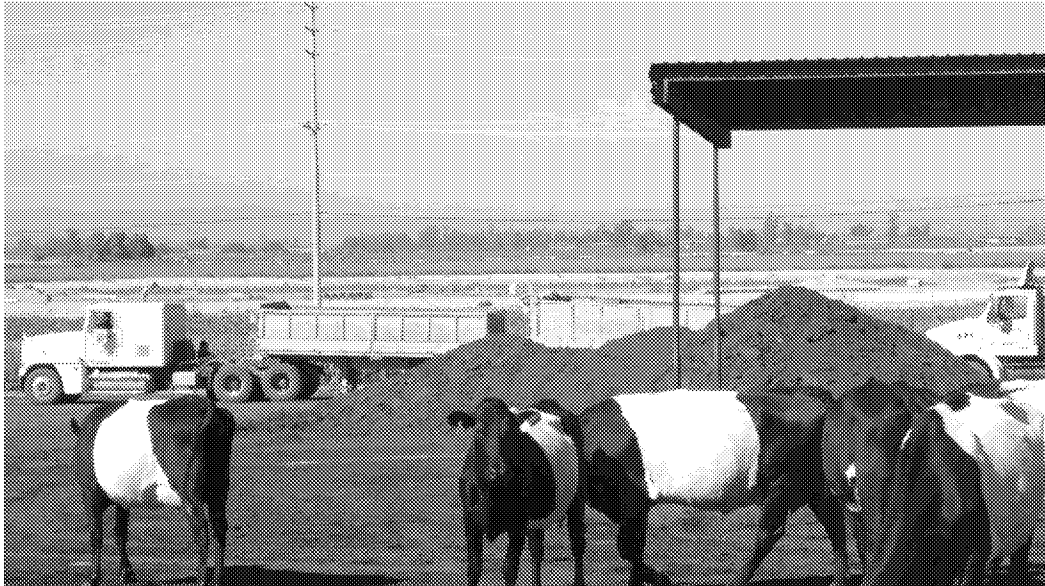
Photo 3: Corrals being scraped and manure being hauled off

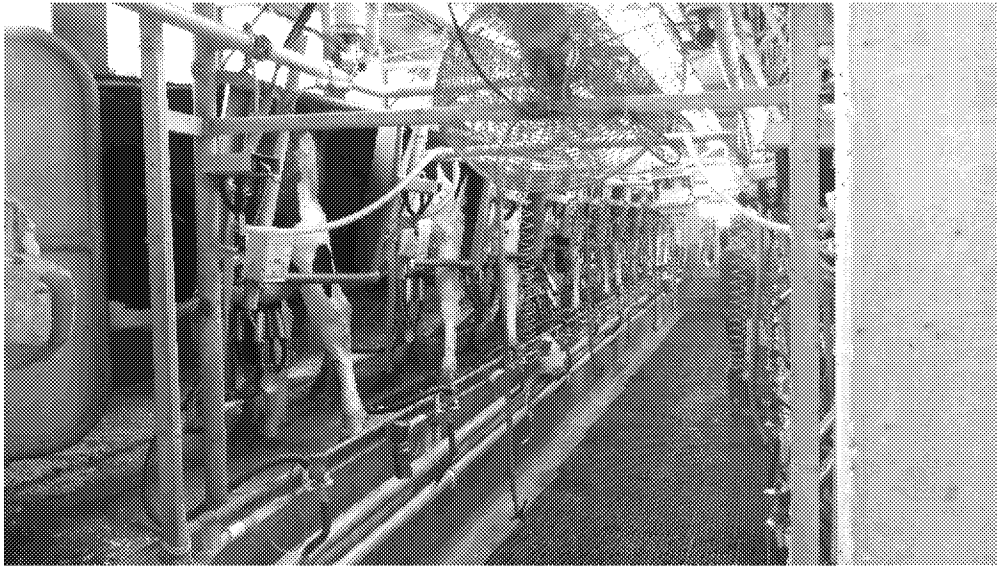
Photo 4: milk barn

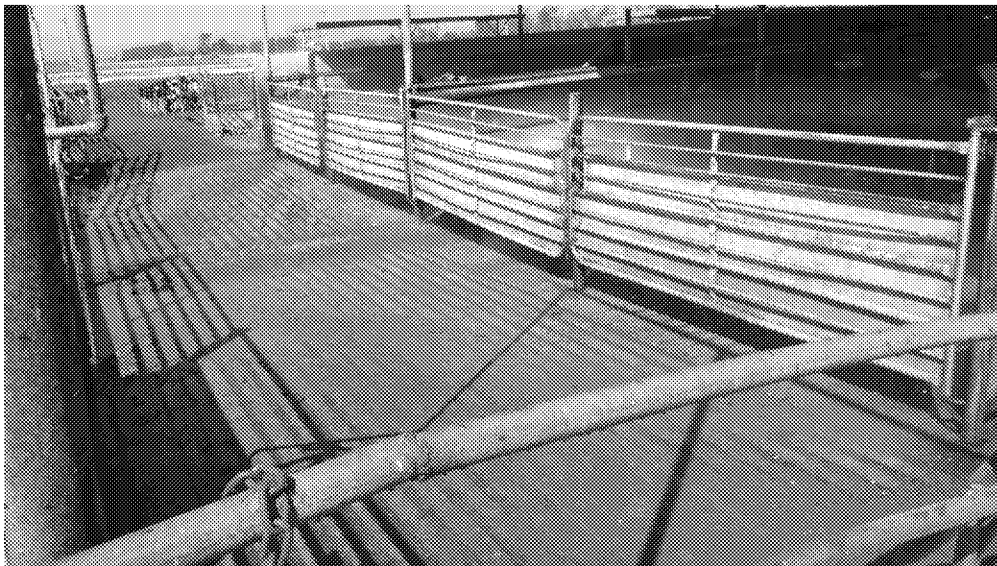
Photo 5: wash areas next to milk barn

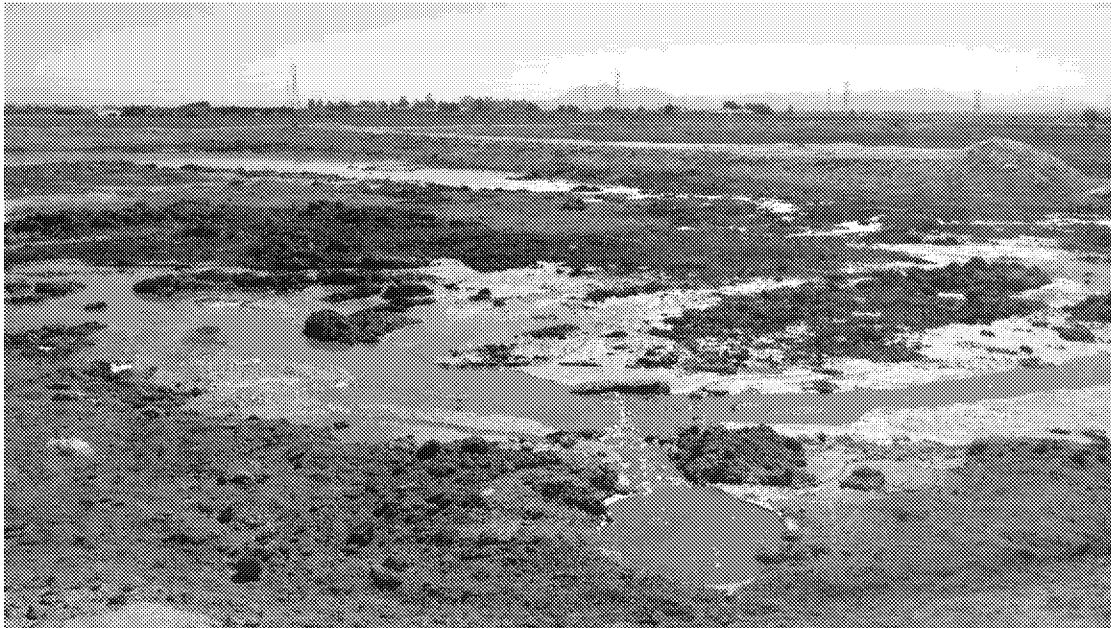
- Several ponds appeared to have excess solids with accumulation more than 2 feet deep. However, the majority of the ponds appeared to have sufficient storage capacity based on EWMP design, which includes a total of 16 ponds. The operator indicated the ponds will likely be scheduled for cleaning next year.

No evidence of significant rodent damage, erosion, or excess vegetation along berms was observed. Ponds generally clear of vegetation. Several ponds appeared to have excess amount of sediment buildup.

Photo 6: washwater flowing into pond. Build-up of accumulated sediments.

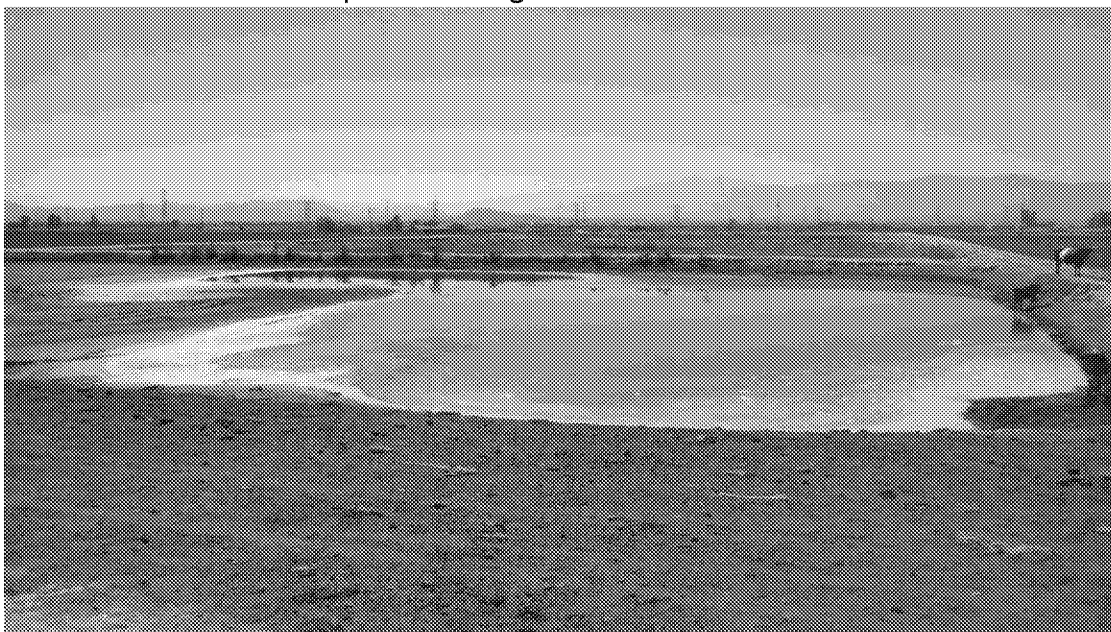
Photo 7: View of series of ponds looking south

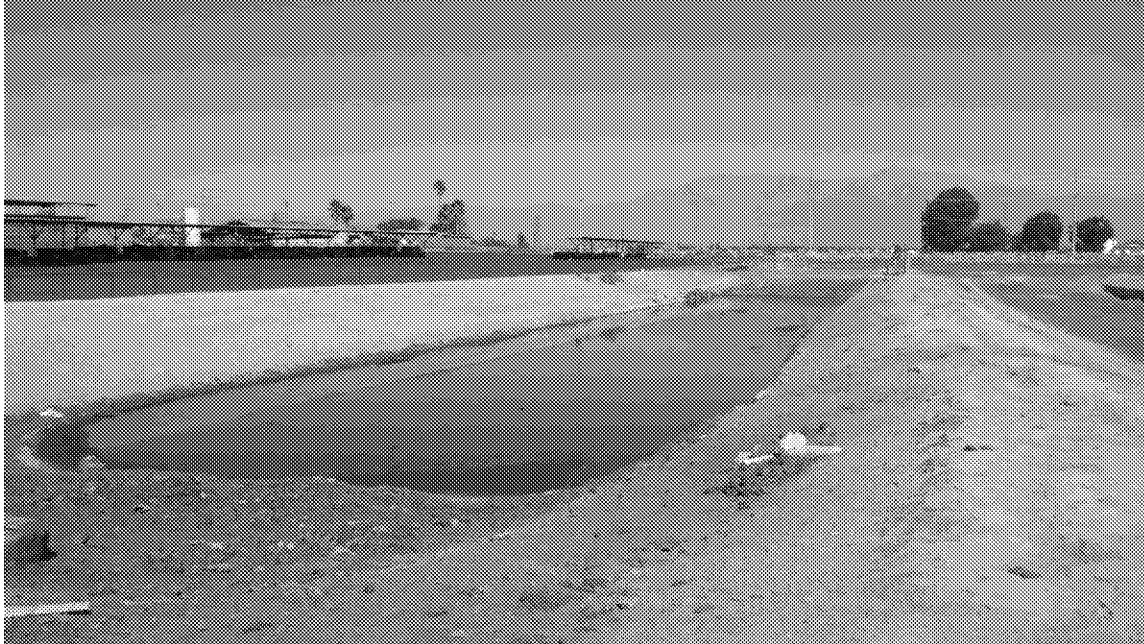
Photo 8: Northern pond; View looking northwest.

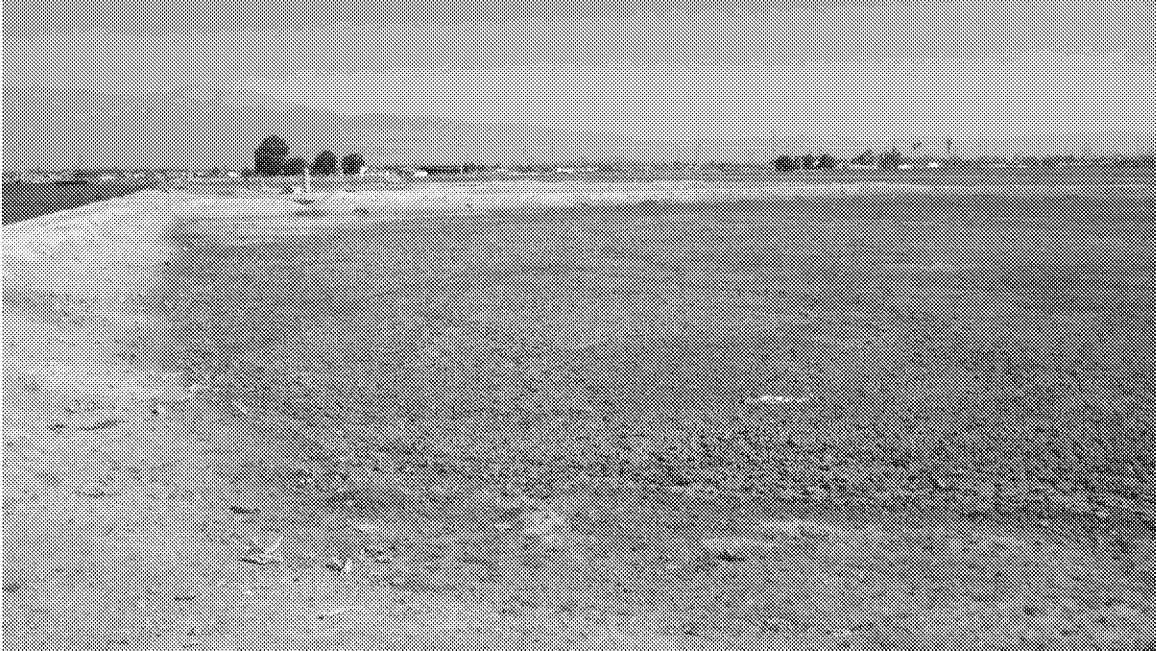
Photo 10: Pond view looking north

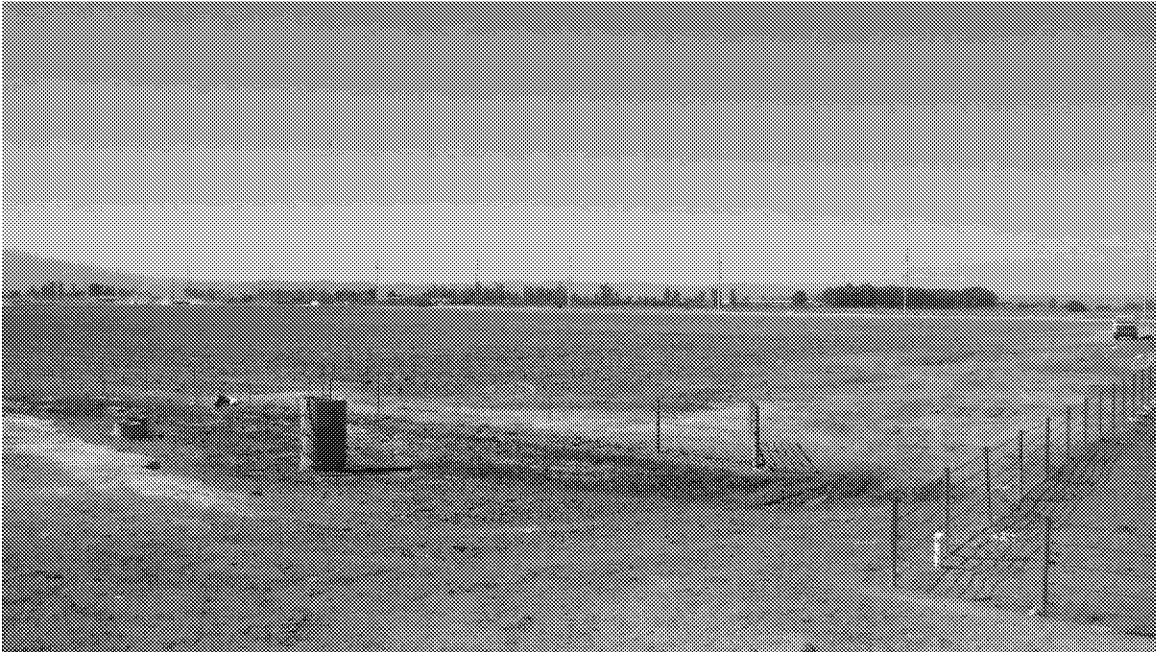
Stormwater flows in a southern direction. Stormwater from the corrals either flows to the northernmost ponds, or flows to the southern fields which are used a pasture land (photo 11). Operator stated that the pasture may be converted to croplands in future.

Photo 11: view of pasture area / cropland looking southwest

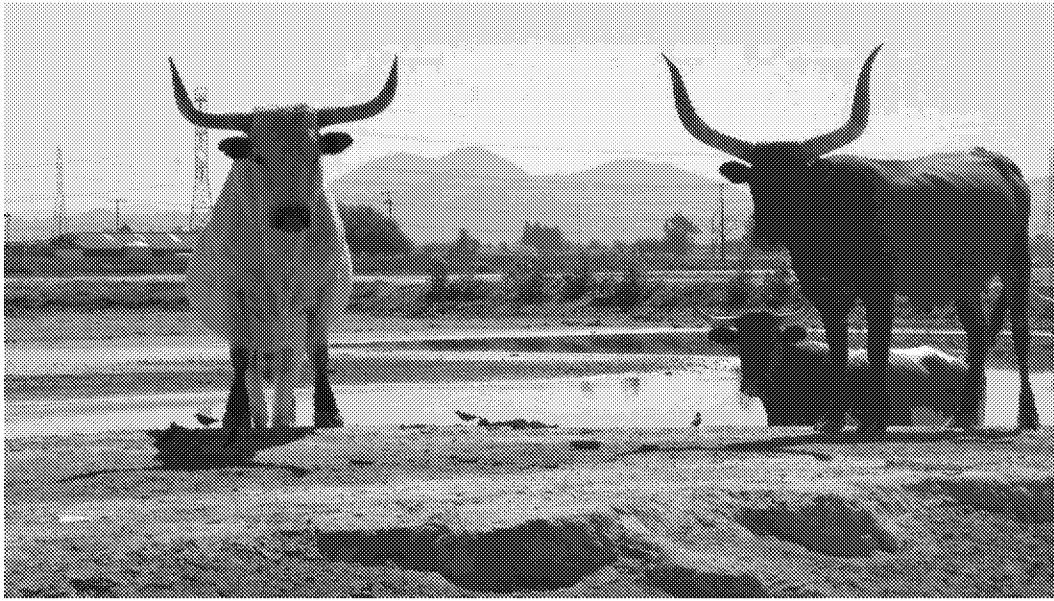
Operator indicated that berms were severely overgrown several years ago. The operator found the most effective way to manage the vegetation was by using longhorns (see photo 11). The operator keeps 20 longhorn to control vegetation along the berms and lagoons and in the pasture.

Photo 12: Longhorns.
